HIGHLAND CREEK AND TRIBUTARIES

1971

REPORT ON  
AN OUTFALL SURVEY  
OF  
HIGHLAND CREEK AND TRIBUTARIES  
WITHIN  
THE MUNICIPALITY OF METROPOLITAN TORONTO

DISTRICT ENGINEERS BRANCH  
DIVISION OF SANITARY ENGINEERING  
DECEMBER, 1971

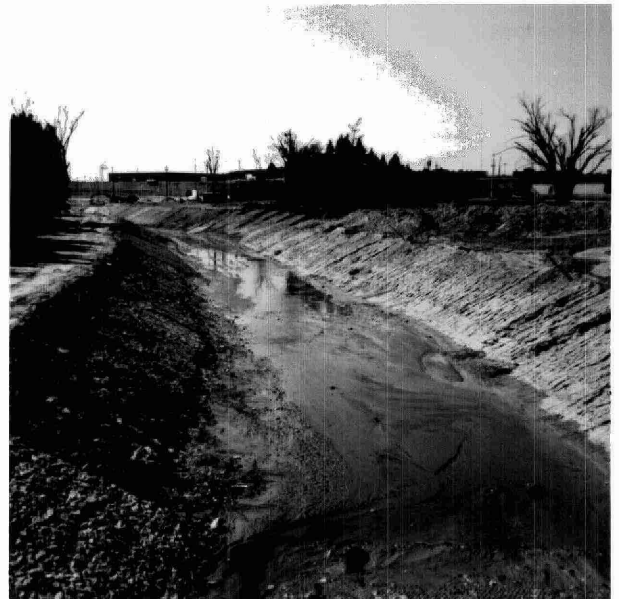
Part of North Branch in a construction area, showing stone gabion in left foreground.

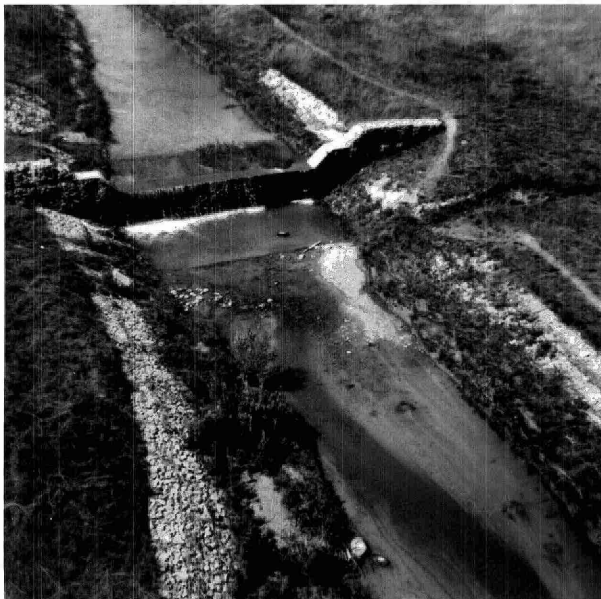
Silting in North Branch above Ellesmere Road.
